Using Avance[®] Solo

A few things to keep in mind if you are receiving treatment with Avance[®] Solo negative pressure wound therapy (NPWT) system.

You are receiving treatment with Avance® Solo NPWT from Mölnlycke®. This brochure will inform you on how to use and care for the device. Please read it carefully.

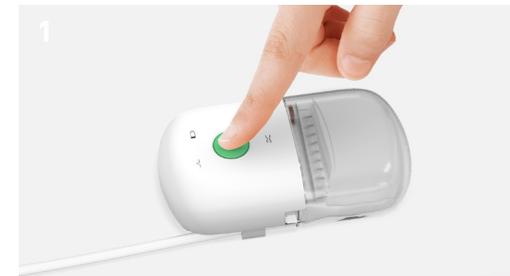
1 Pause therapy by pressing down the green start button, and release after two (2) seconds.

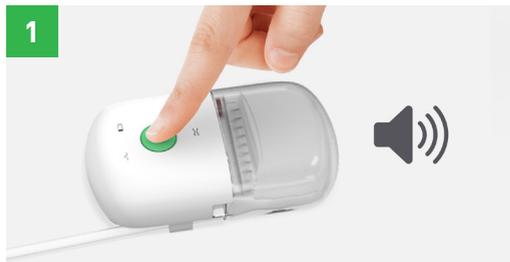
1 Pause the pump by pressing down the green start button, and release after two (2) seconds. The pump will emit two beeps to confirm it is in pause mode.

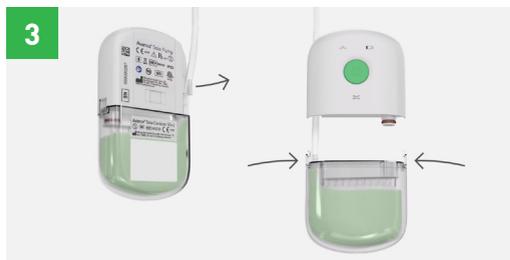
3 Release tubing at the back of the pump. Press hard on the side-mounted plastic tabs and pull while gently rocking to disconnect the canister. Connect the new canister. You should expect the canister to be a firm fit, this is normal and necessary for maintaining an effective seal.

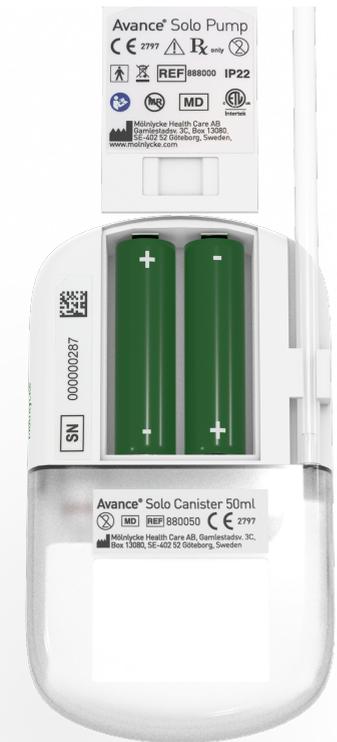
Changing the batteries

You must change the two (2) batteries if there is a Low battery alarm, or after 7 days. Only use AA 1,5V GP15LF lithium batteries.

- If the pump is still active, pause the pump by pressing down the green start button, and release after two (2) seconds
- Open the battery compartment by sliding the lid
- Remove the batteries
- Insert new batteries, ensuring that the positive terminal (marked +) and negative terminal (marked -) of each battery matches the +/- label in the battery compartment
- Close the battery compartment lid
- Restart the pump by pressing down the green start button, release after two (2) seconds. Make sure that the negative pressure is active, the dressing should be contracted and firm to the touch
